Rapid Assessment Report

Naubad Karez

Covering previous conservation efforts, current conditions
and urban takeover.

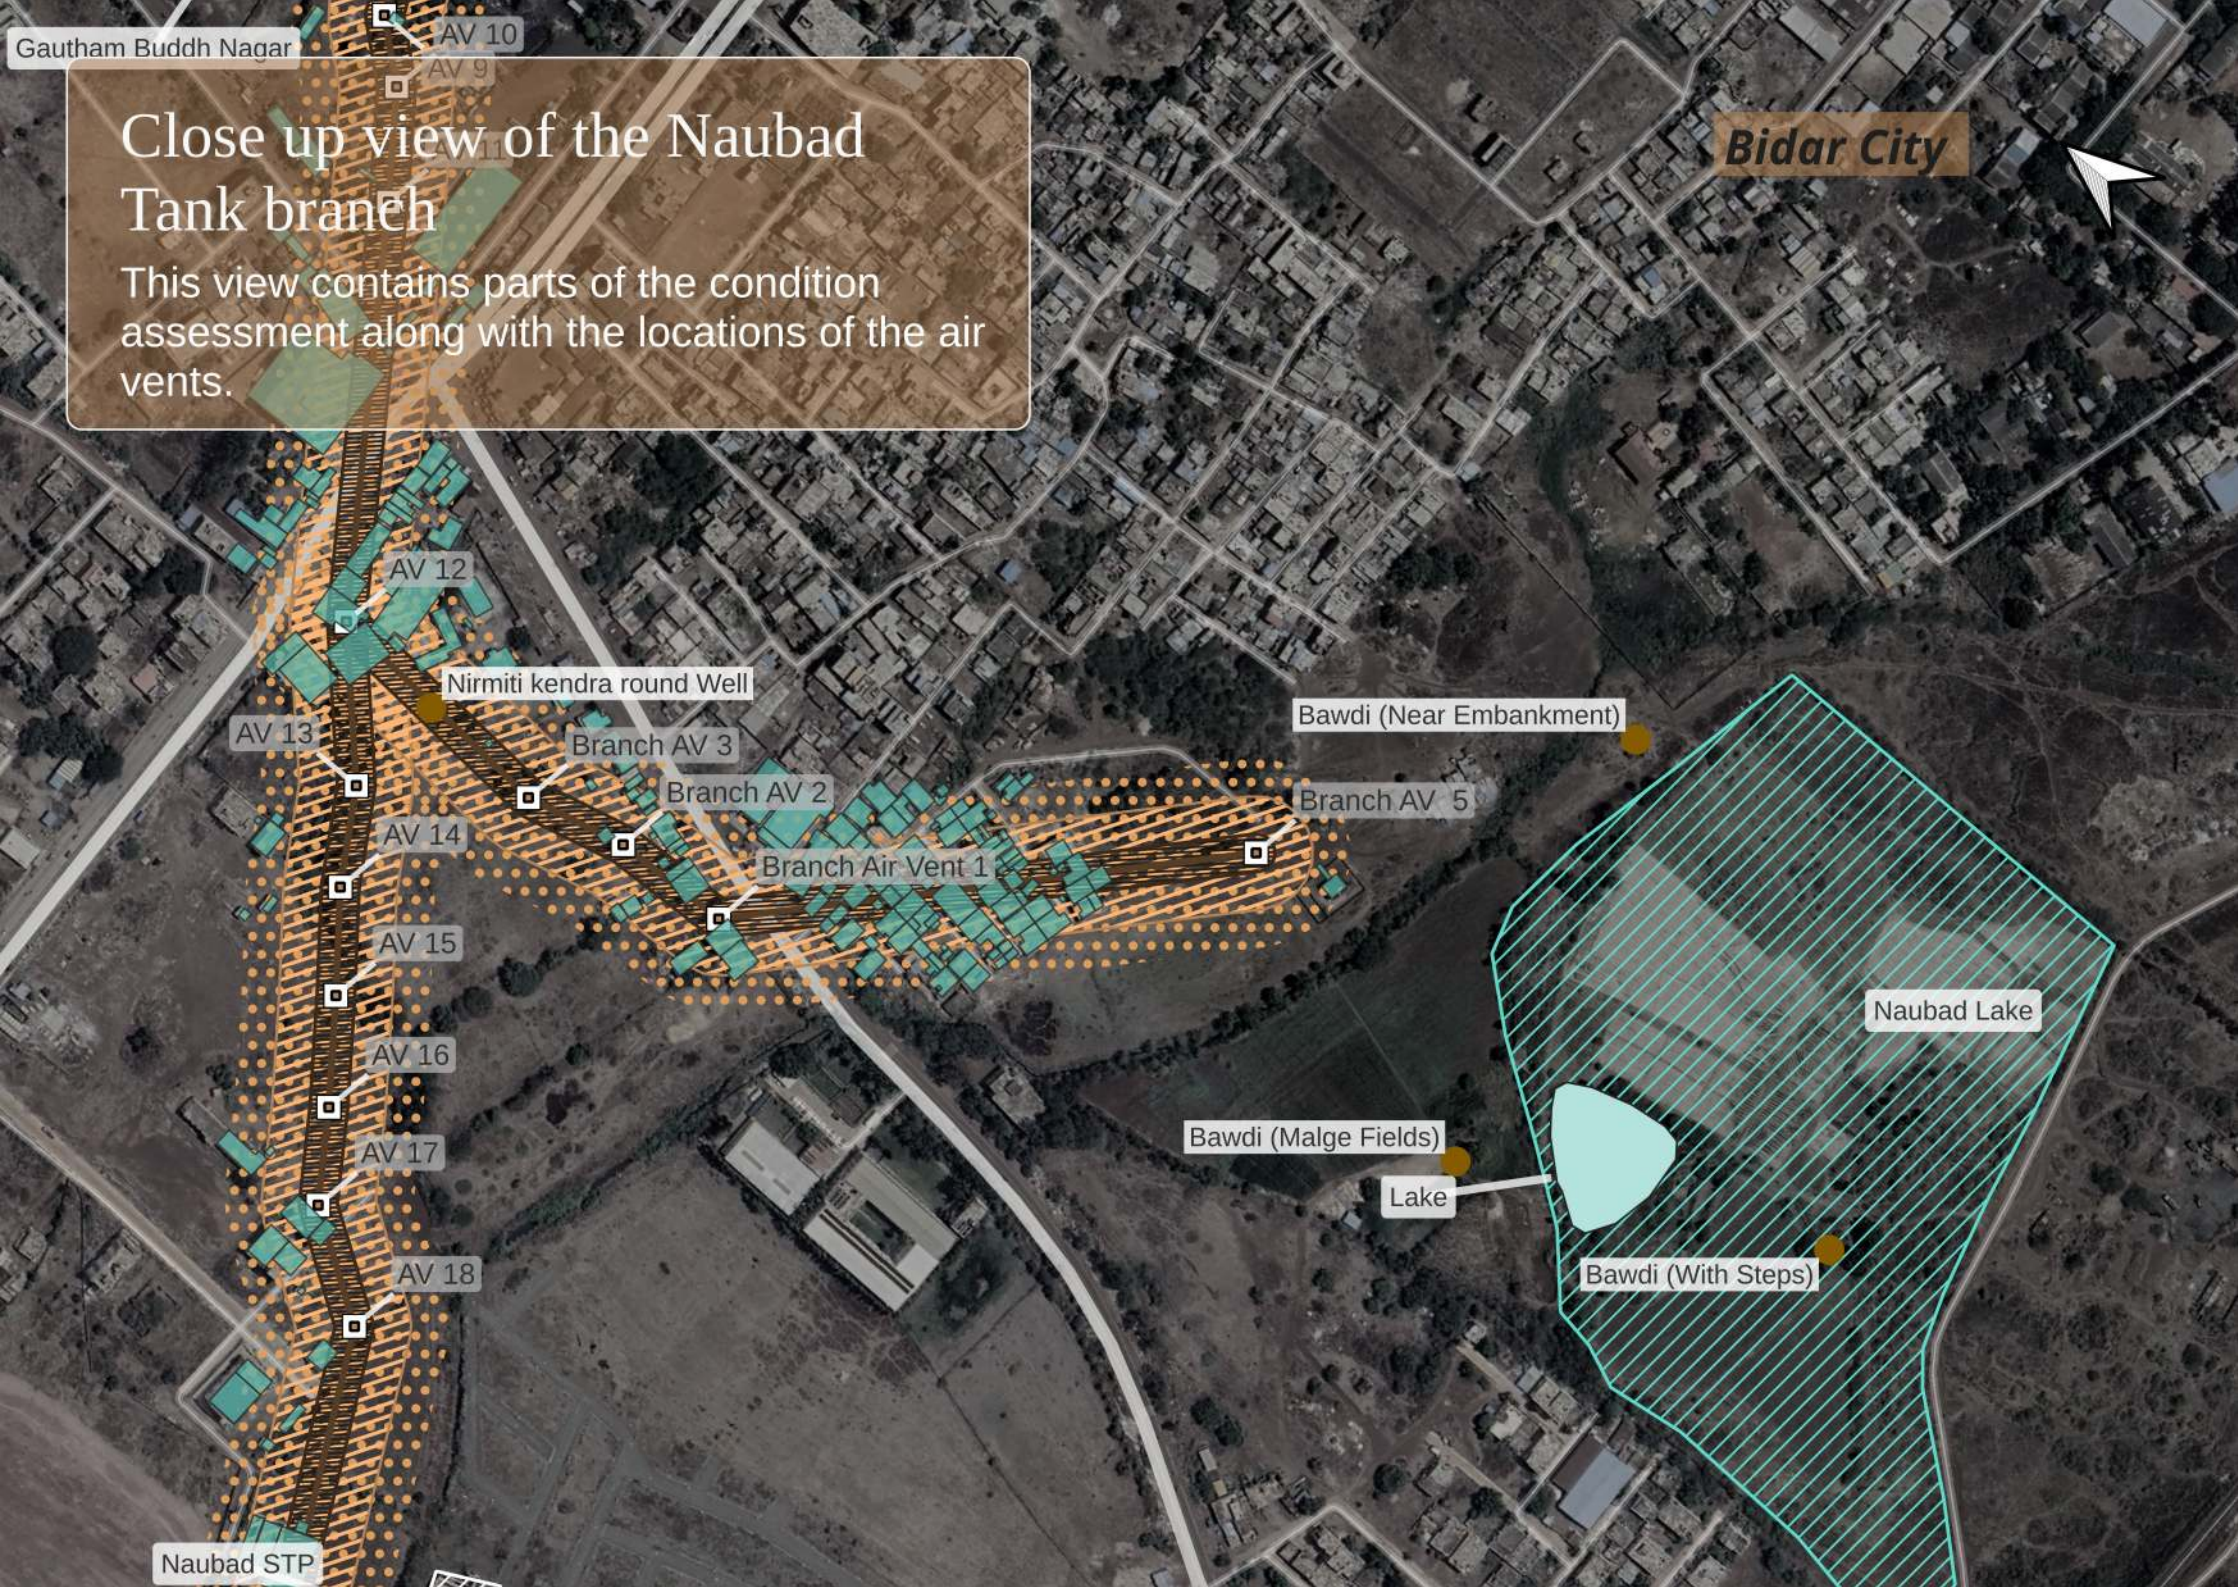
Close up view of the Naubad Tank branch

This view contains parts of the condition assessment along with the locations of the air vents.

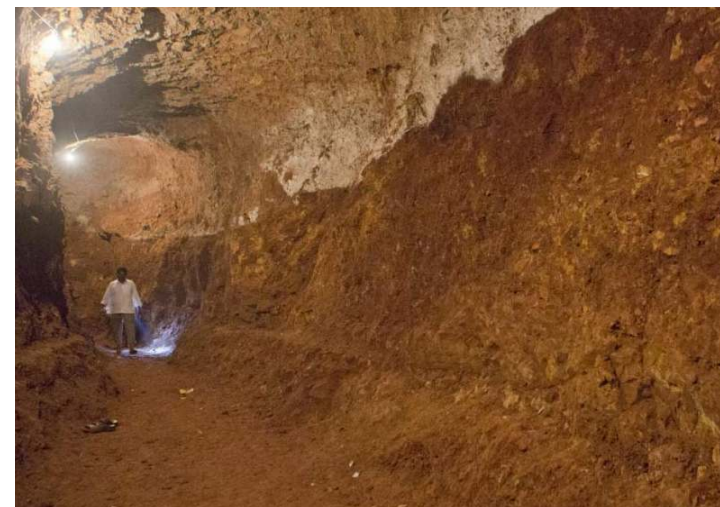
Post cleaning assessment of the Karez, September 2016

On September 15, 2016, after 15 months and the removal of thousands of tonnes of garbage, decomposed soil, and silt, the system was revitalized with water filling the entire Karez line and some vents holding significant amounts of water. The outflow was observed, and water filled the Siddeshwara Kunda, subsequently flowing through vegetation and filling streams beyond the connecting road to Aliabad.
